**Subject: Annual Inspection Report  
Pryor Field Regional Airport**

# ANNUAL INSPECTION REPORT

APRIL 12, 2011

PRYOR FIELD REGIONAL AIRPORT  
DECATUR, ALABAMA

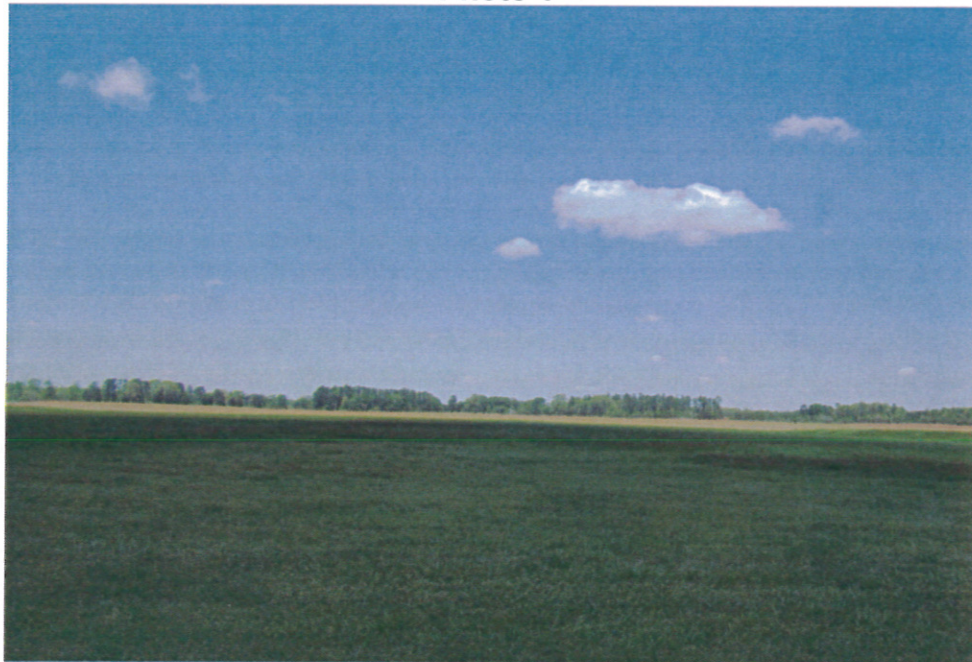
**Photo 1**

- The approaches to the runway ends are unobstructed and meet licensing requirements.

Approach to Runway 18

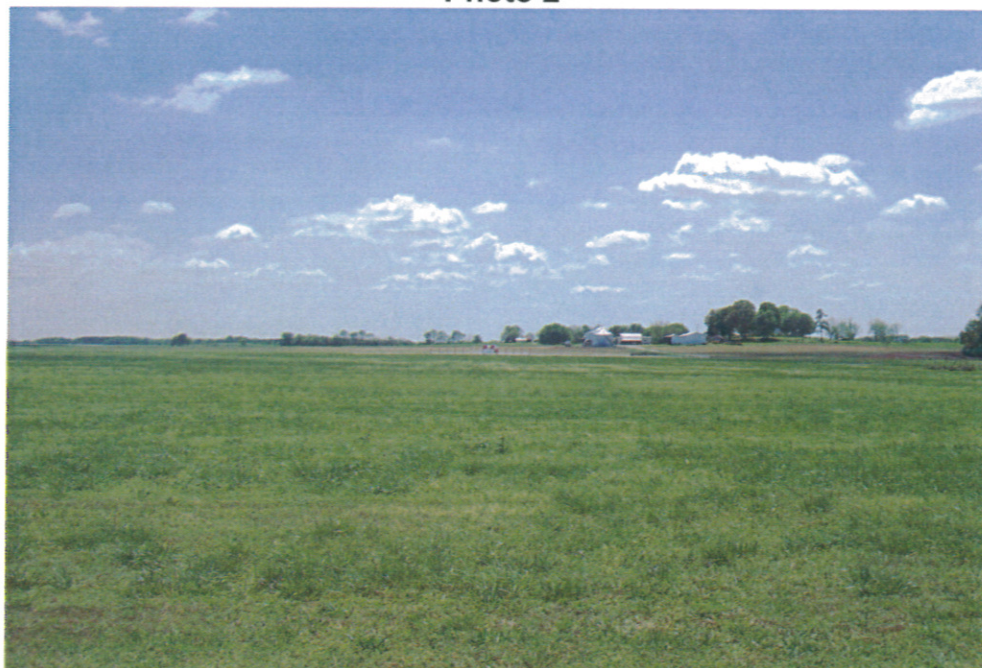
**Photo 2**

Approach to Runway 36

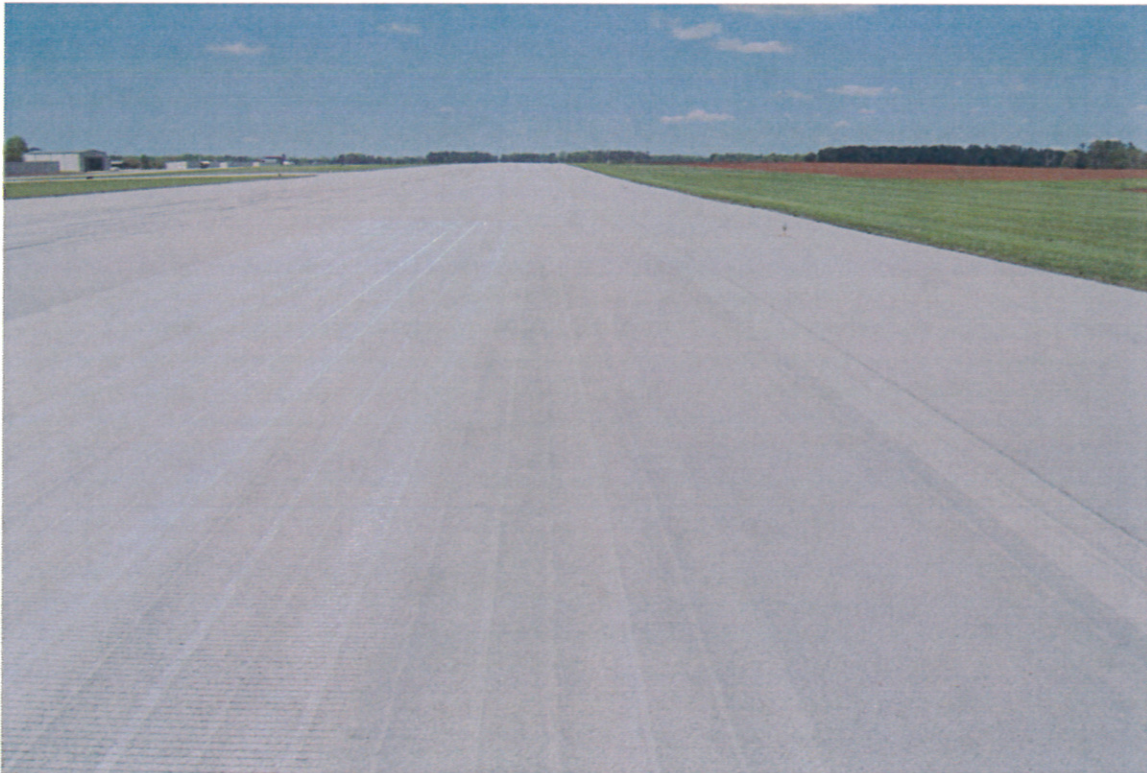
Photo 4

- The airport markings are in faded condition and must be reapplied in the near future.

Aiming bar and runway edge marking in Poor condition

- The runway markings must be reapplied in accordance with FAA Advisory Circular 150/5340-1K "Standards for Airport Markings".

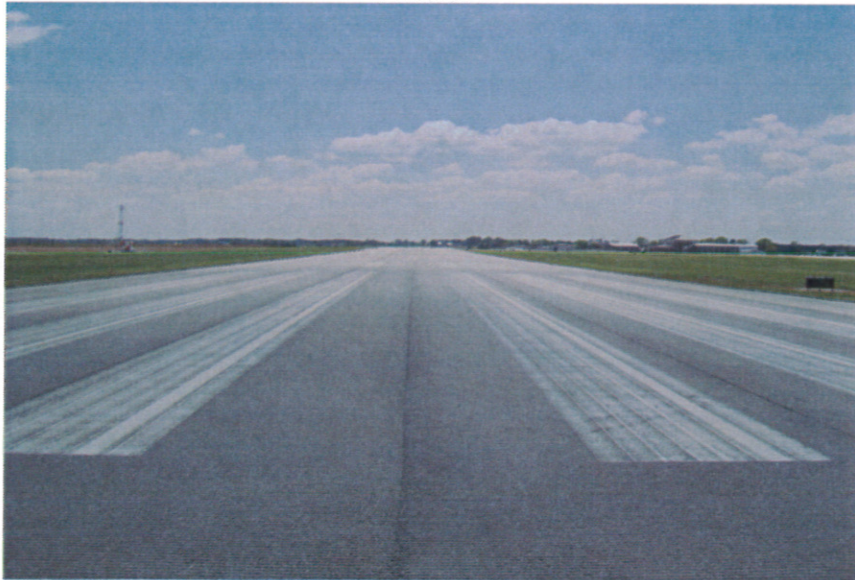
**Photo 5**

Runway 18 threshold markings

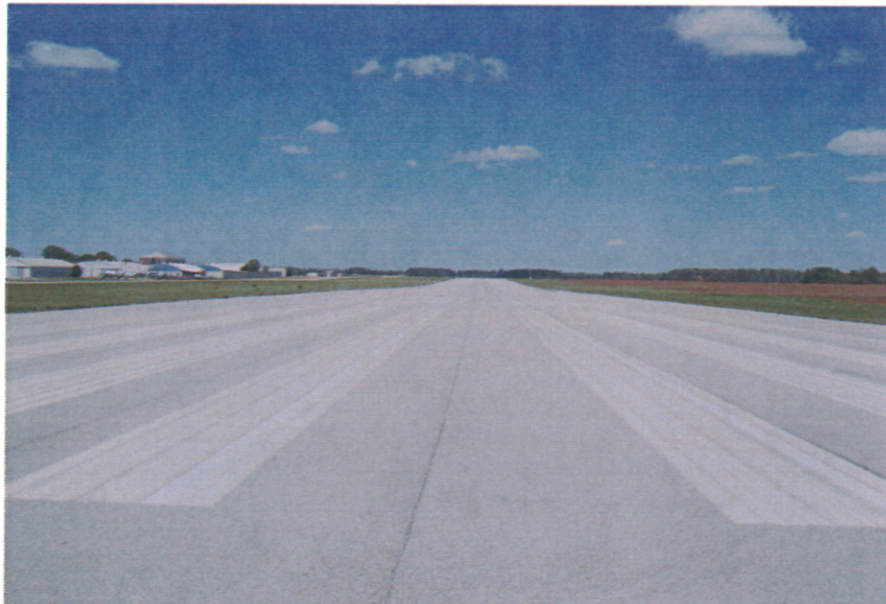
**Photo 6**

Runway 36 threshold markings

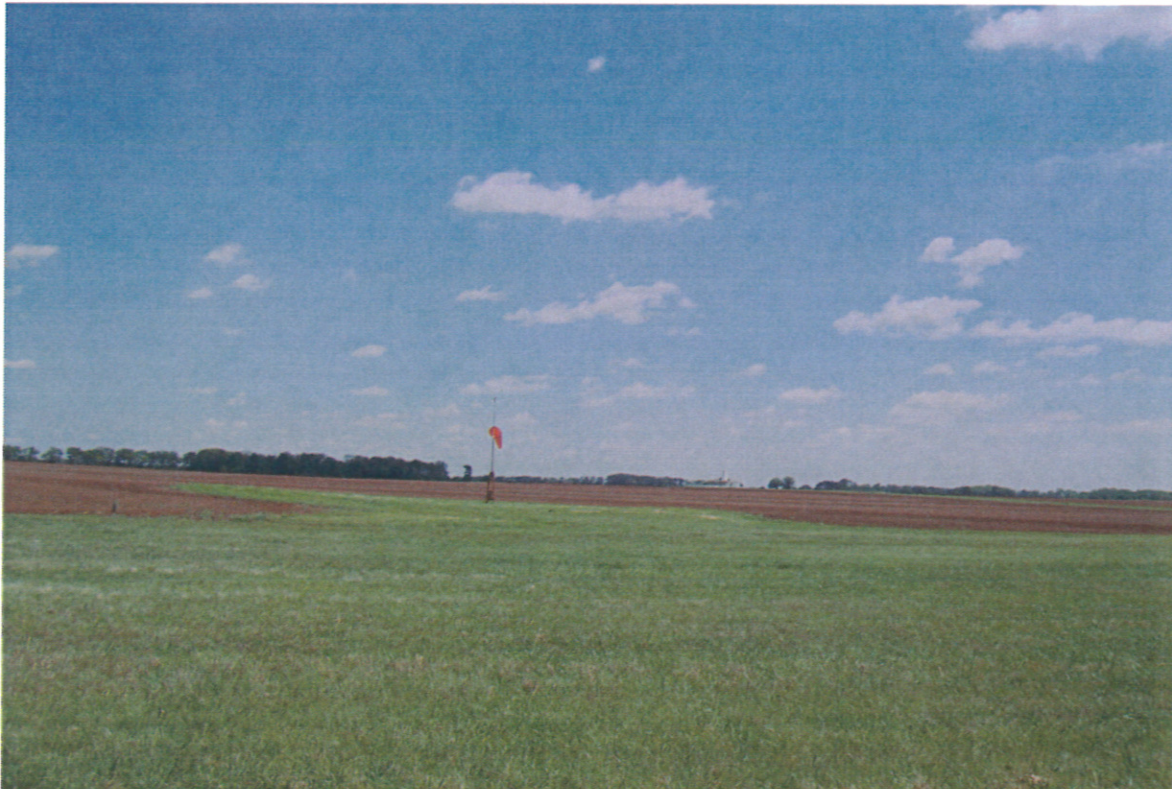
Photo 8

- The wind sock is operational and lighted.

Windsock assembly and segmented circle

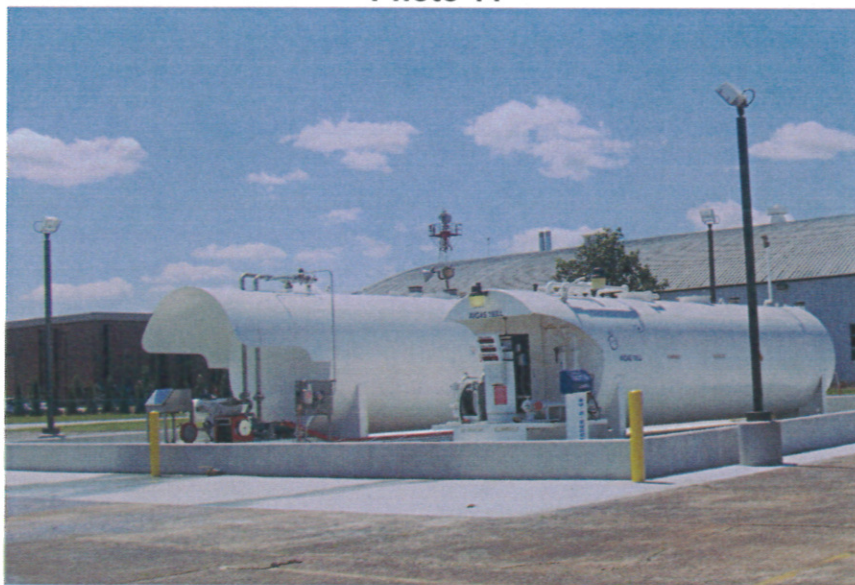
Photo 11

- ➔ The self-serve fueling is out of service. Fueling is being accomplished by fuel trucks.
- ➔ The fueling area and trucks meet the requirements established by the Alabama Department of Transportation. However the State of Alabama Department of Agriculture and Industries may have additional requirements for fueling systems that were not considered during this inspection.

Fueling Area
